SPARC® Enterprise M4000/M5000 Servers Product Notes

For XCP version 1041

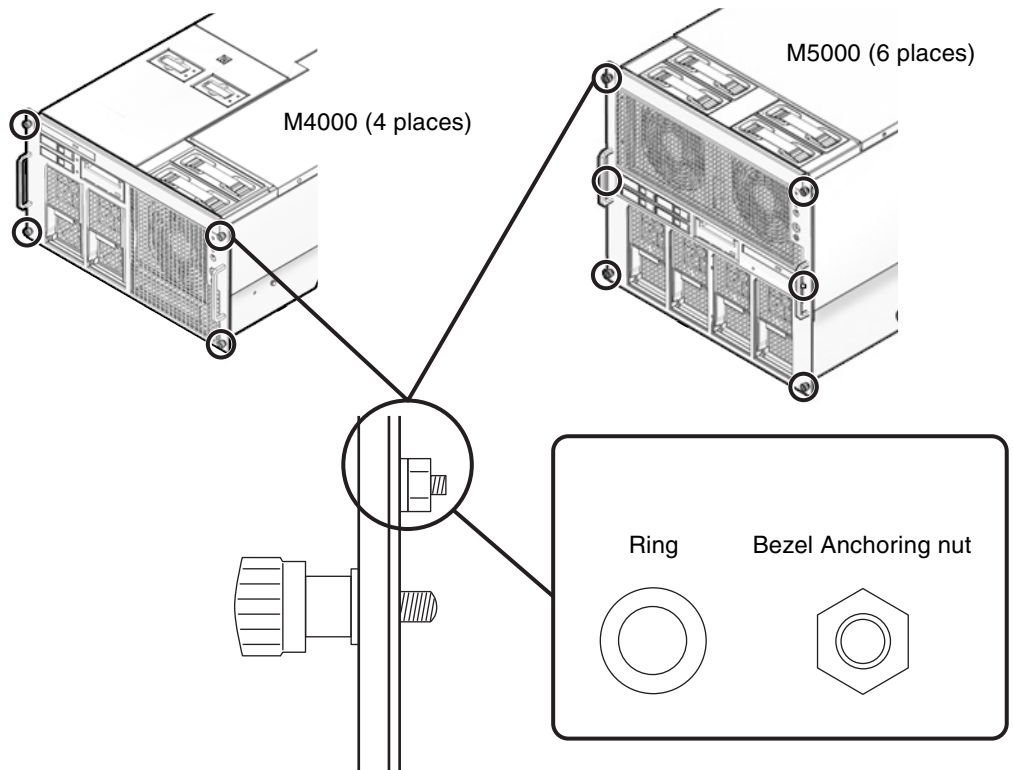
When you mount the SPARC Enterprise M4000 or M5000 server on the 19-inch rack, as you insert it all the way seated in the rack, the nut anchoring the bezel may interfere with the rack column and the server may fail to be seated correctly.

In such a case, please replace the bezel anchoring nut and ring with the E-Ring.

1. Remove the interfering bezel anchoring nut and ring.
